Manhole Inspection Summary

Manhole # S21CC_049MH

Location Address: **1013 BRUCE ST** Cross Street: **RIGGS-MOSHER**

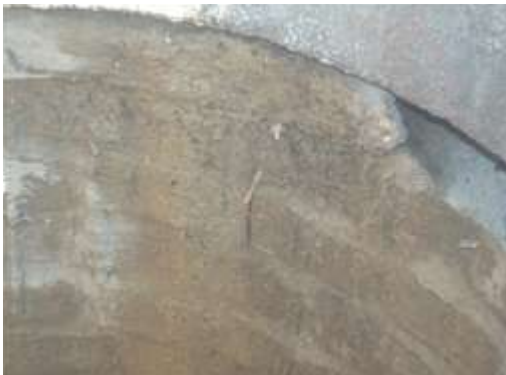
Defect 3

Infiltration: ☐ None ☒ **Joint** ☐ Cracks ☐ Mortar ☐ Roots ☐ Wall

INFILTRATION OF CORBEL

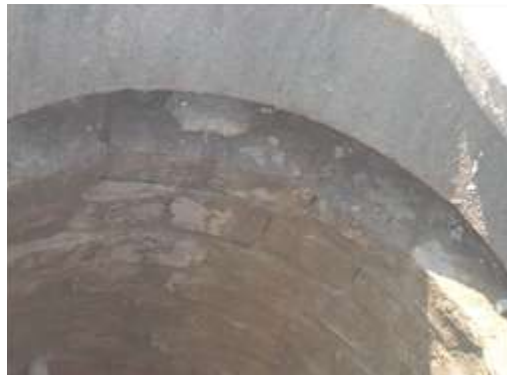
Defect 2

Condition: ☐ Sound ☐ Cracked ☐ Root Intrusion ☐ Loose Brick ☒ **Deteriorated**

DETERIORATION CORBEL

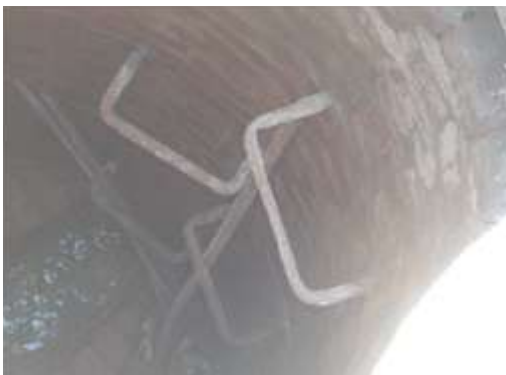
Defect 1

Steps Count: **4** Missing: **0** ☒ **Corroded**

CORRODED STEPS

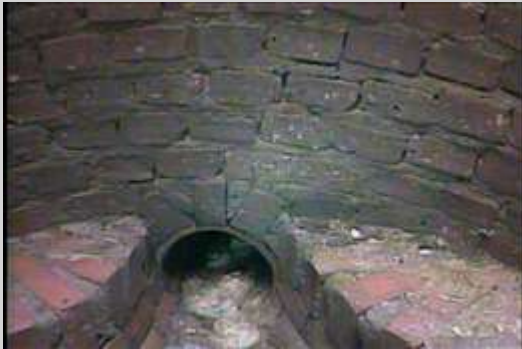
12 O'Clock Outflow

8 in. Circular Gravity Sewer
Pipe Out @ 12 O'Clock

Pipe Height: **8.4** (in.) Rod and Bar (Angled)
Pipe Material: **Clay** ☐ Pipe Lined
Invert Depth: **9.52** (ft.) Flow Characteristics: **Slow**
Deposits: ☐ None ☐ Mud ☐ Sludge ☒ **Debris** ☐ Grease
Silt Depth: **2** (in.) Deposits Extent: **Light**
Infiltration: **None** Pipe Seal Cond: **Sound**

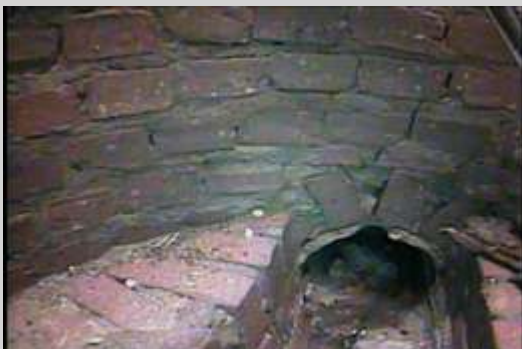
3 O'Clock Inflow

8 in. Circular Gravity Sewer
Pipe In @ 3 O'Clock

Pipe Height: **8.4** (in.) Rod and Bar (Angled)
Pipe Material: **Clay** ☐ Pipe Lined
Invert Depth: **9.12** (ft.) Flow Characteristics: **Slow**
Deposits: ☐ None ☐ Mud ☒ **Sludge** ☐ Debris ☐ Grease
Silt Depth: **4** (in.) Deposits Extent: **Heavy**
Infiltration: **None** Pipe Seal Cond: **Sound**
